ASSESSMENT OF COMMUNITY ASSETS (INFRASTRUCTURE AND
ECOSYSTEMS) VULNERABLE TO COASTAL STORMS AND SEA LEVEL RISE

HAMILTON, LAKKA, TOMBO, CONAKRI-DEE, SHENGE & TURTLE ISLAND

Assessment Report Submitted to UNDP

December, 2018

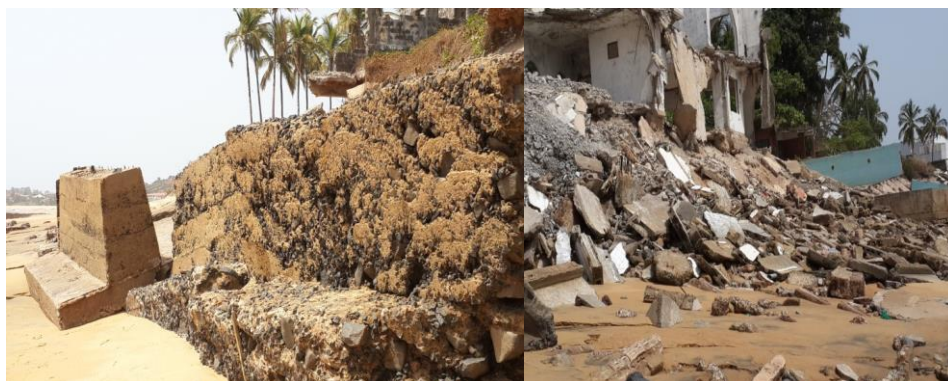
Photo showing destructions to Hotels along Lakka beach

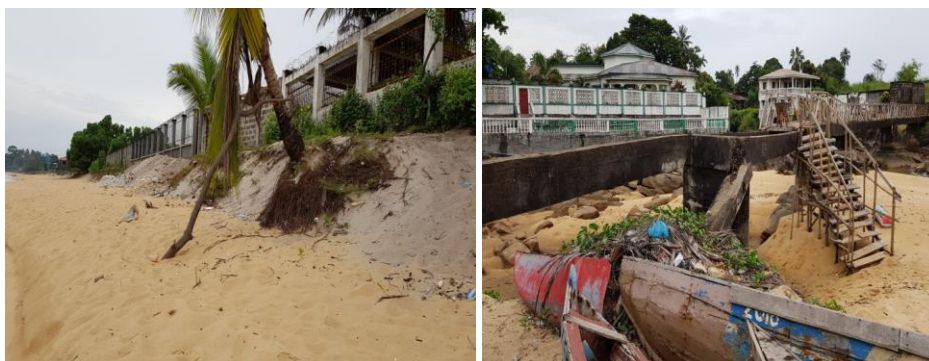
Coastal erosion effects on Shoreline and Coastal assets in Hamilton

The effect of coastal erosion was visible and the study shows that coastal assets along the shoreline in Hamilton could be at high risk to sea level rise and storm in the near future (see photos above).

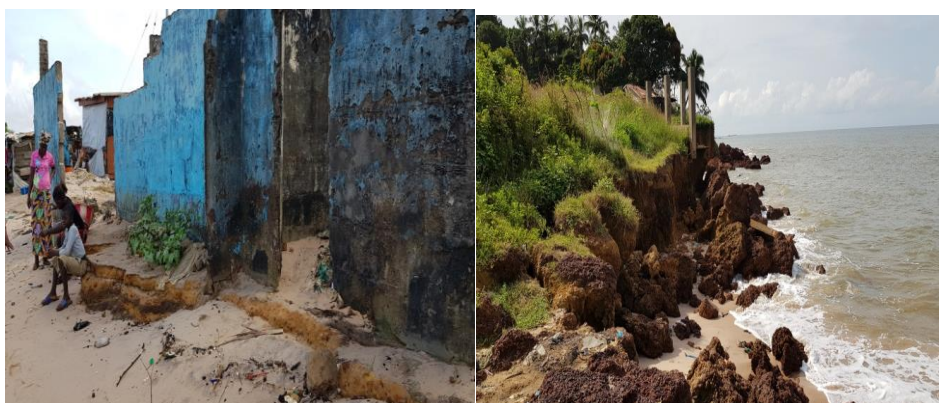
Given the rapid shoreline recession, some property owners have constructed some form of non-mechanical coastal defense by placing a number of sand bags at the beach front with the aim to reduce the rapid erosion as a means to protect their properties.

Shoreline erosion and effects of houses in Conakri-Dee

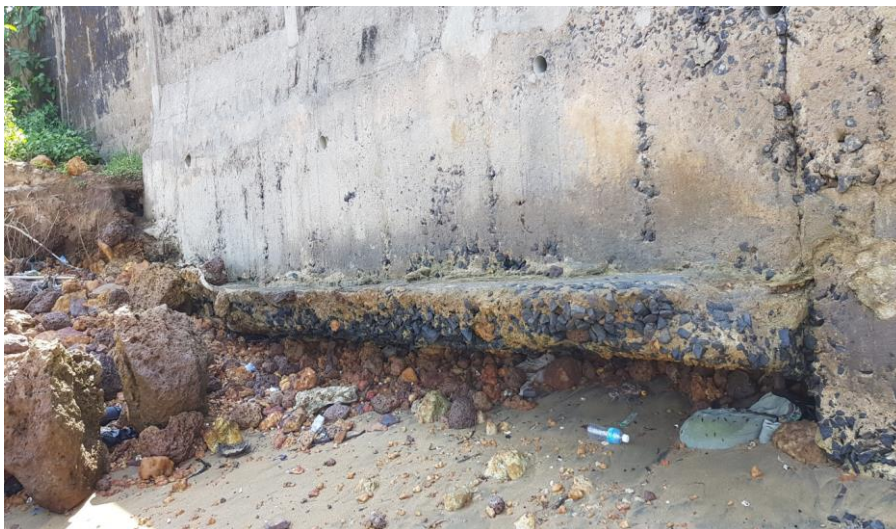
Effect of erosion on the walls of the Fish processing facility in Tombo

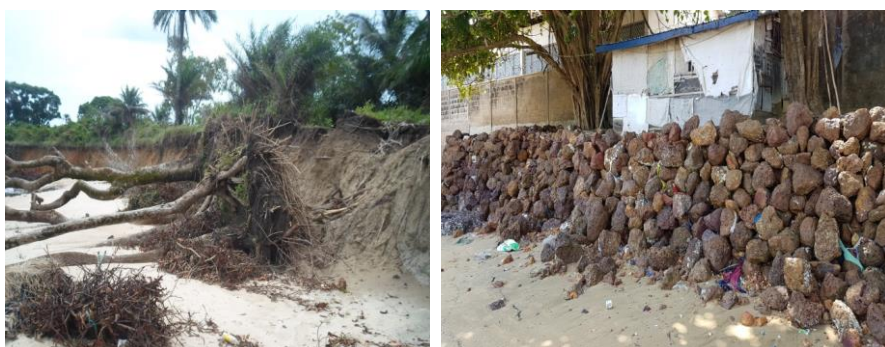
Left: Erosion of Shoreline in Shenge; Right: Shoreline protection initiative by Locals of Tombo

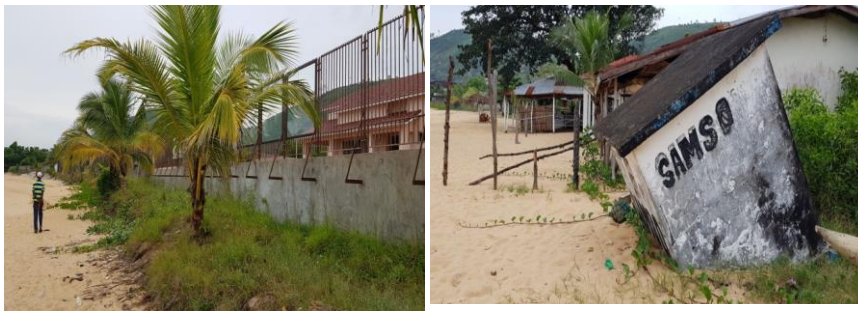
Left: In Hamilton, coconut trees planted on the beachfront have been exposed to coastal erosion and many uprooted; Right: Public shower ruined as a result of storm and erosion

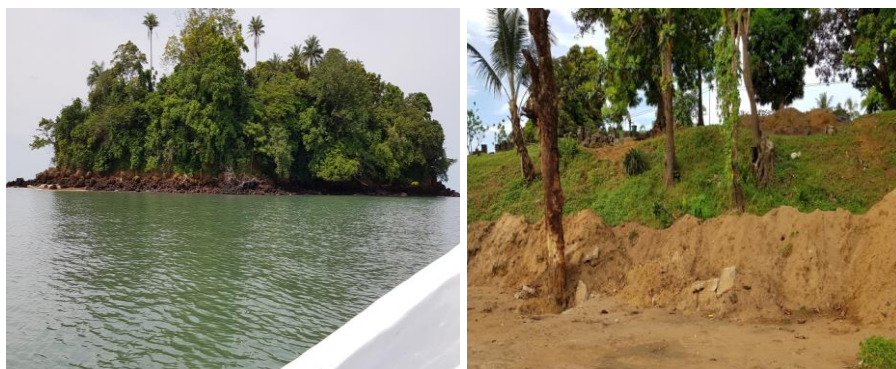
Left: The banks of Monkey-island in Shenge has been sustained by the presence of rocks; **Right:** The presence of Cliffs in Shenge town has reduced the risk of damage to houses

The peculiar nature of the shoreline in Shenge presents unique features of the coastal erosion threats and the cumulative resulting impacts. Some areas with high cliff have outcrop of boulders and these present natural coastal protection and have over the years reduced the rate at which the land is taken up by the water. Observations show the indentation of the shoreline geomorphology indicating the different rate of the erosion in areas with natural protection and those without protection. In Shenge the only assets protected by mechanical defense structure is the fishery processing complex, but this facility is now facing serious threat from erosion resulting to damage to the asset.

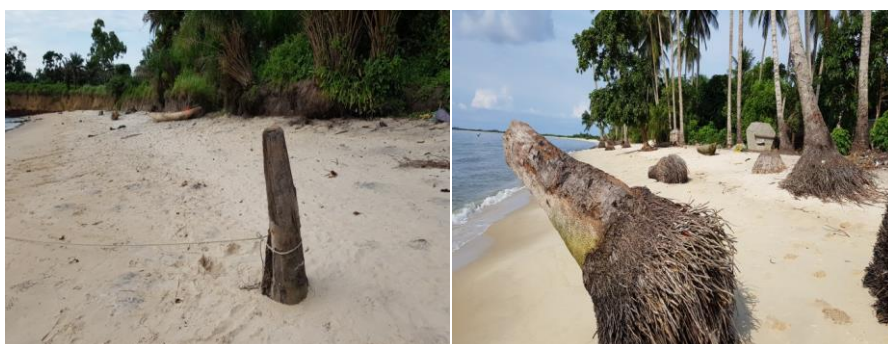
Photo showing the impact of shoreline erosion in Turtle Island

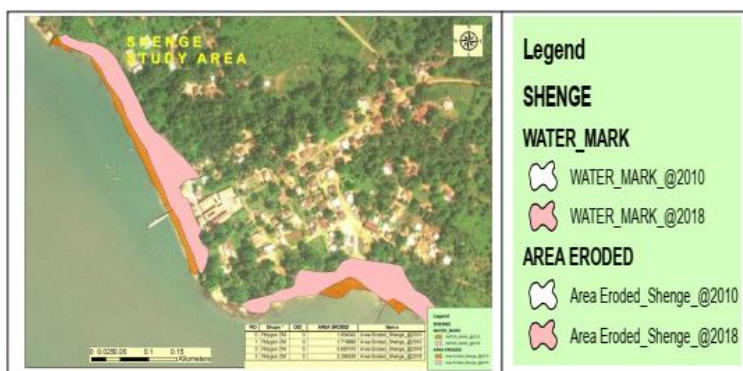
Figure 7: Shoreline change in Shenge area

In Shenge (Figure 7), unlike the other pilot sites, coastal erosion is massive and the rate is very rapid but not with uniform intensity across the length of the shoreline due to multiple factors.

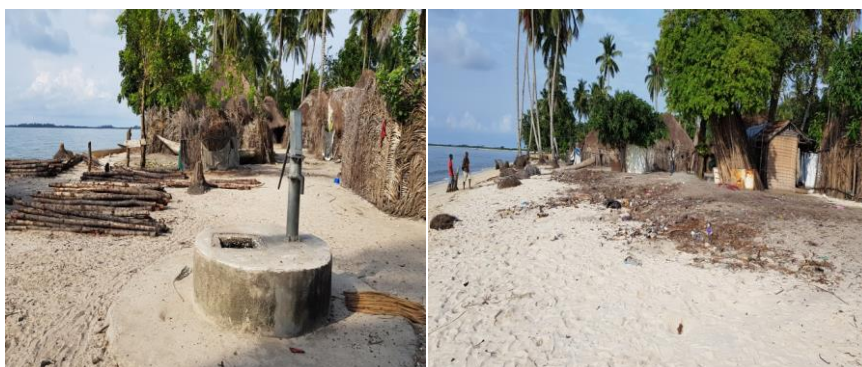
In Turtles Islands, one of the noticeable indications showing the relative speed at which the sea is advancing is the current location of the water tap which was constructed in the middle of the Bumpe-Tok village over 5 years ago.

Photos showing effects of sea level rise and coastal erosion in Turtle Island

The choice of the location was to have a sustained service, but during the assessment it was observed that the location of the tap is now almost about 30m from HWM and many houses surrounding the tap have already been destroyed. The tap is no longer useful as the sea level rise has led to decreasing the water table and the intrusion of salt water rendering the water unfit for drinking.

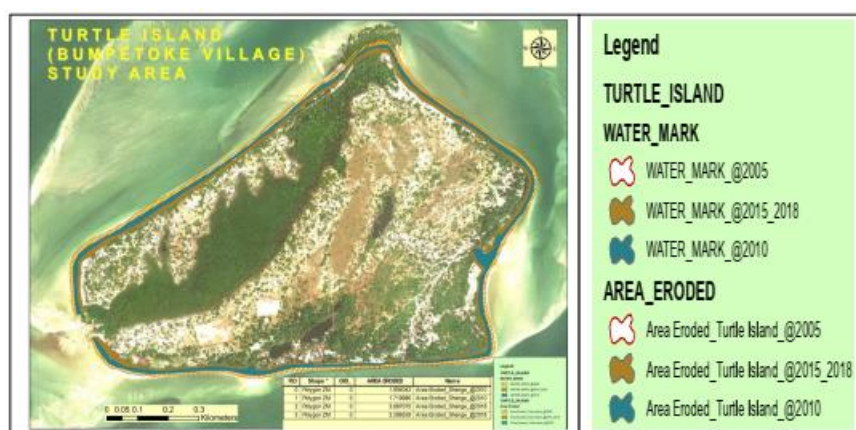
Figure 8: Shoreline change in Turtle Island

In Turtle Island, the coastal recession show the least when compared with other sites giving the difference between the water mark in 2005 (baseline) and 2018 as 29.0m.

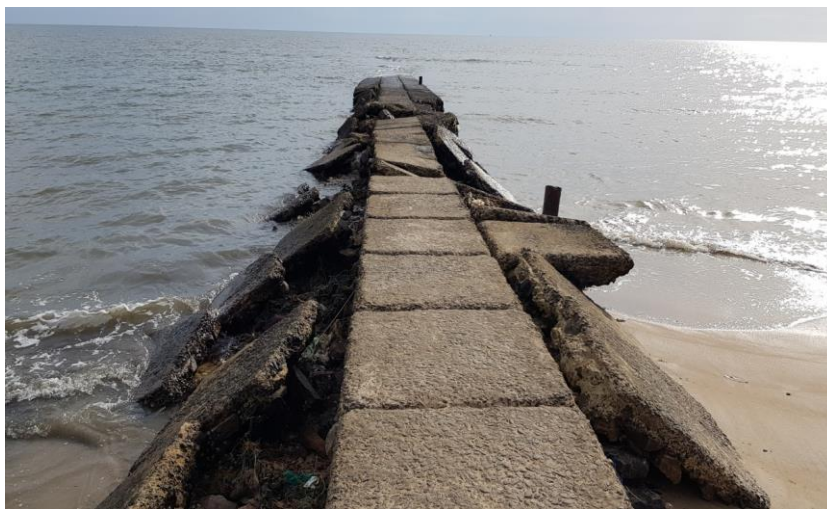
Photo showing the old jetty in shenge in a dilapidated state

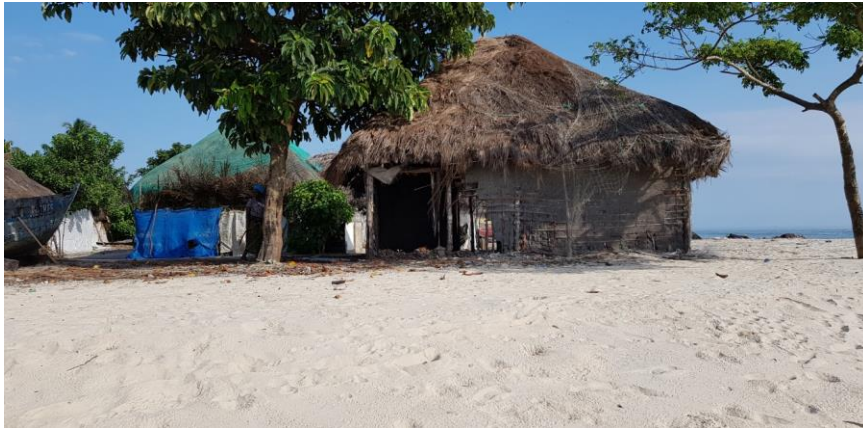
All houses on this island are built of mud with some having corrugated iron roof and many having thatches as main roofing material. There were physical evidences to show shoreline erosion and the destructions caused to trees which were planted by the community to serve as protection and barrier against storm and wave effects. In Bumpe tok village, a number of coconut tree trunks were spotted and debris of concrete houses destroyed by the advancing seawater. The coastline protection measures adopted here is the natural protection type. Hundreds of coconut trees were planted on the beachfront for the purpose of shoreline defense against storm and wave actions.

All houses in Turtle are built up of mud as shown in this picture
