# **Analysis of the Causal and Trigger Factors of the August 2017 Landslide in Freetown: towards a Sustainable Landslide Risk Management in Sierra Leone**

**United Nations Development Programme (UNDP)  
Environmental Protection Agency (EPA)**

**Freetown, Sierra Leone**  
October 2017

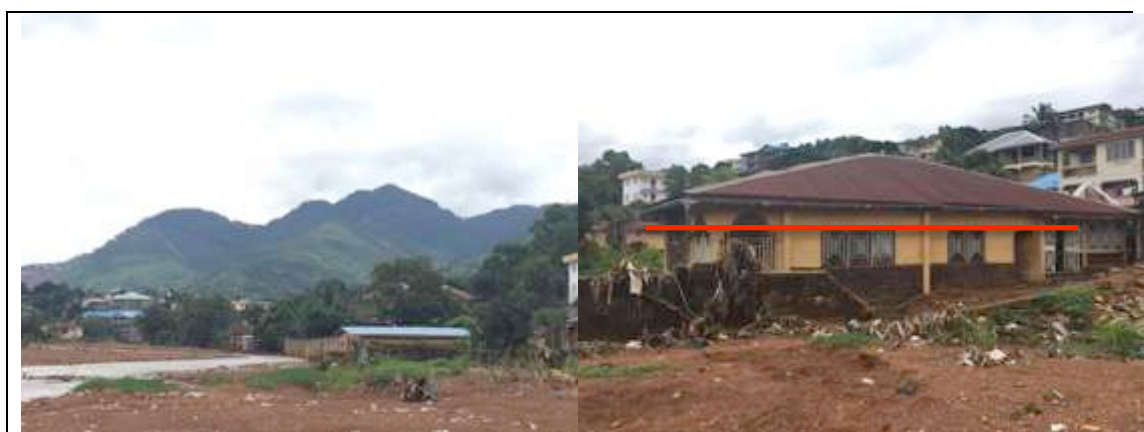
Figure 7-3. General depositional materials consisting of sand to clay sized in the lower part of the slope (from Lumley to Kaningo, left) and the mark of the mudslide deposit (red line) in a one-story house in Kaningo.

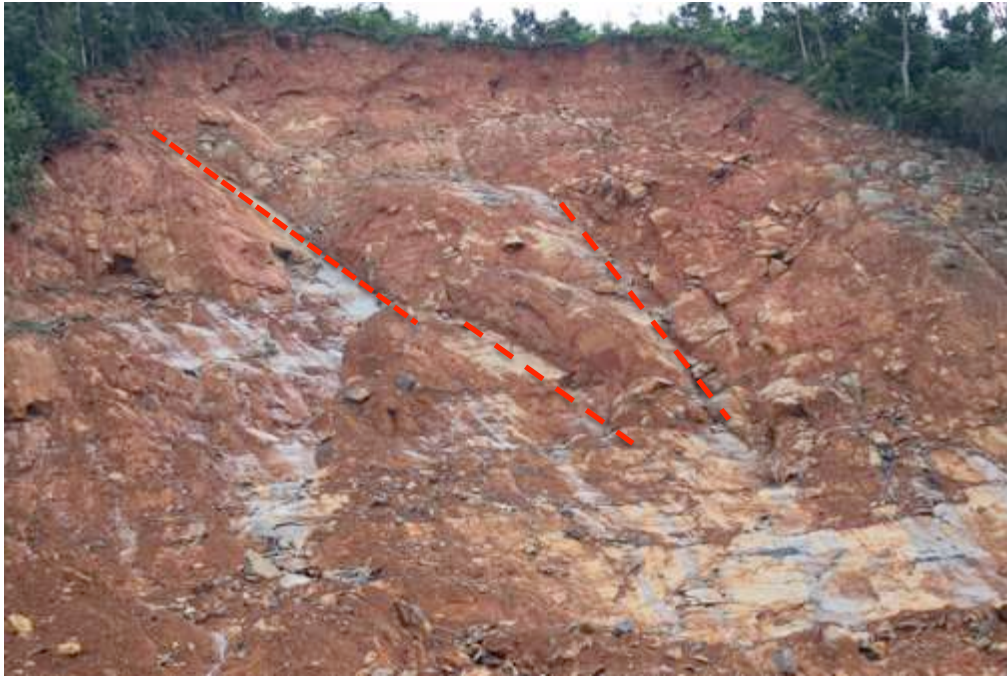
Figure 7-8. Fractured observed on the landslide main scarp (red line), which may be caused by lineament that further formed sliding plane. Photo Credit: Sillah and Williams (2017)

The lineaments may be one of the geological-related causes of the rock fall on the upper part of the slope. Lineaments that form landslide planar are observed at the landslide's main scarp / head in Regent (figure 7-8). At least 3 unconnected seasonal springs were observed flowing over the rock surface that forms the stratum of the weathered loose soil. These springs followed the sliding planar, which may be caused by lineament.

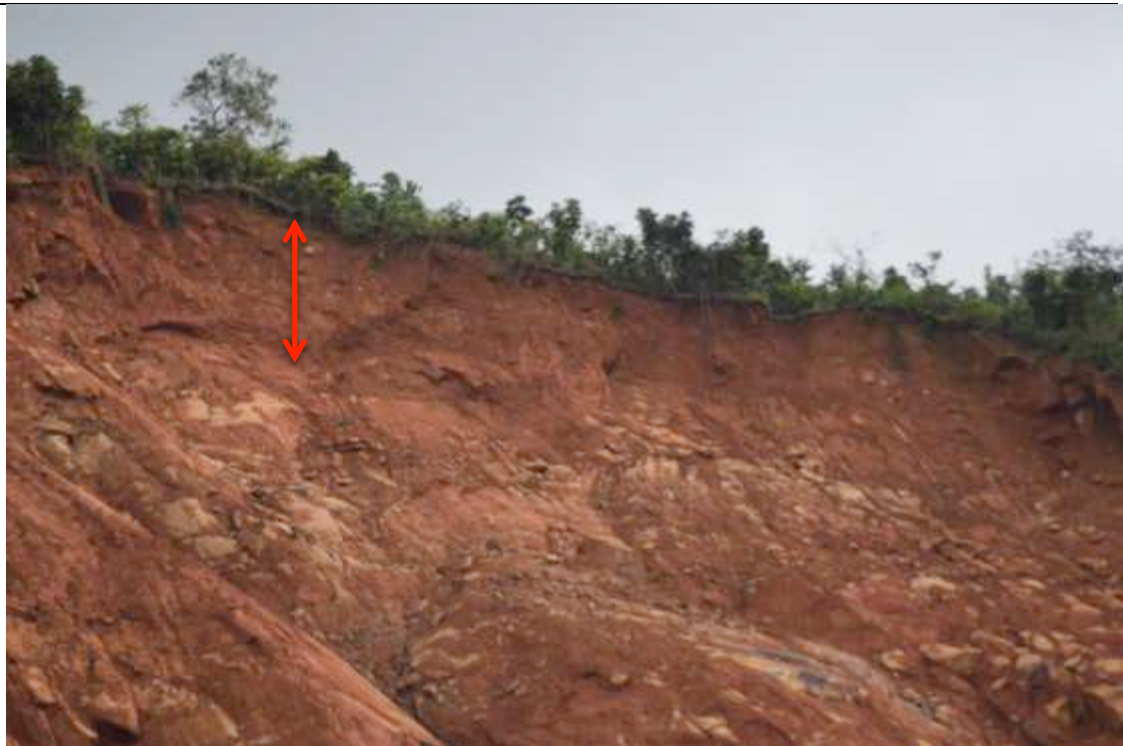
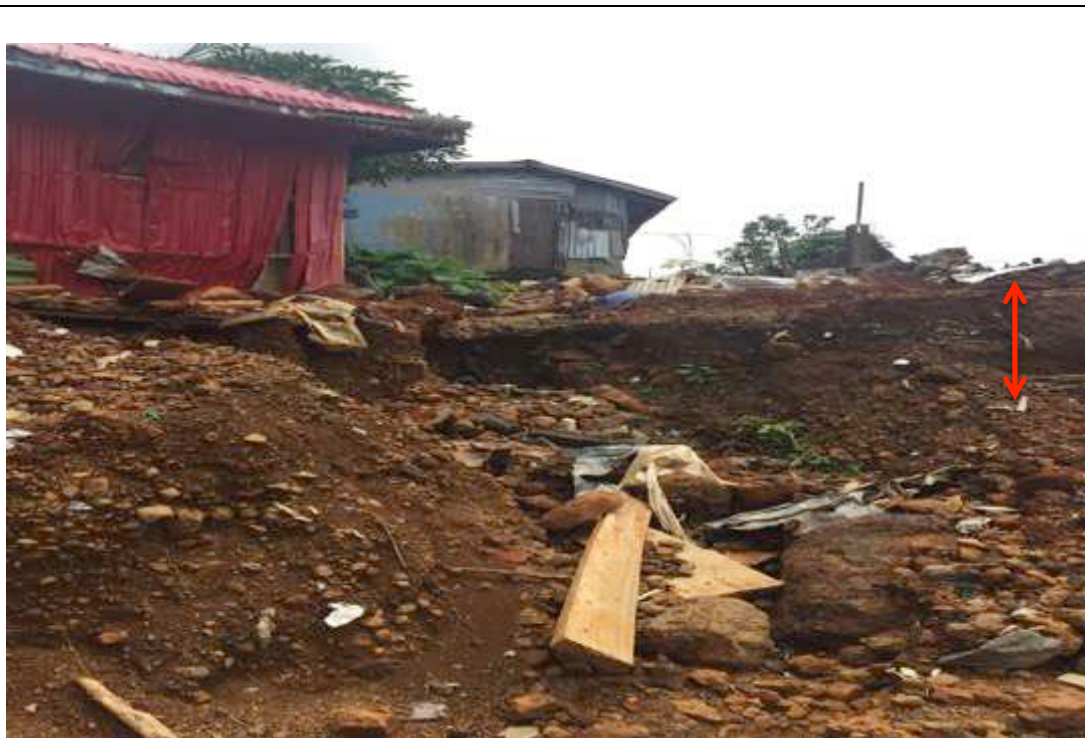
The Weathering profile is relatively thick (looking at the concave point of the breakage) at the top of the ridge. At the body of the landslide, the weathered oxidized material is loose while the underlying bedrock appears to have undergone differential weathering processes (Sillah and Williams 2017). Field observation on the lower part of the slope shows evidence of the heavy weathering of the base rock forming soil with thickness of around 50-60 cm (Figure 7-10).

Figure 7-10. The exposed weather materials at the top of the formation and at the lower part of the slope (upper foto, credit: Sillah and Williams, 2017).

With the top soil has been weathered and relatively thick at the crown crack of the landslide as well as the other areas of the lower parts of the slope (Figure 7-10), water infiltration with more than usual quantity may have destabilized the slope and thus triggered landslides in the lower part; in addition to forced strength causing rock falls at the upper part of the slope. Hence two forces have contributed to the landslide (a) gravity and lineament from the upper part of the slope and (b) slope destabilization at the lower part of the slope due to the erosion, weathering and various human activities triggering landuse change.

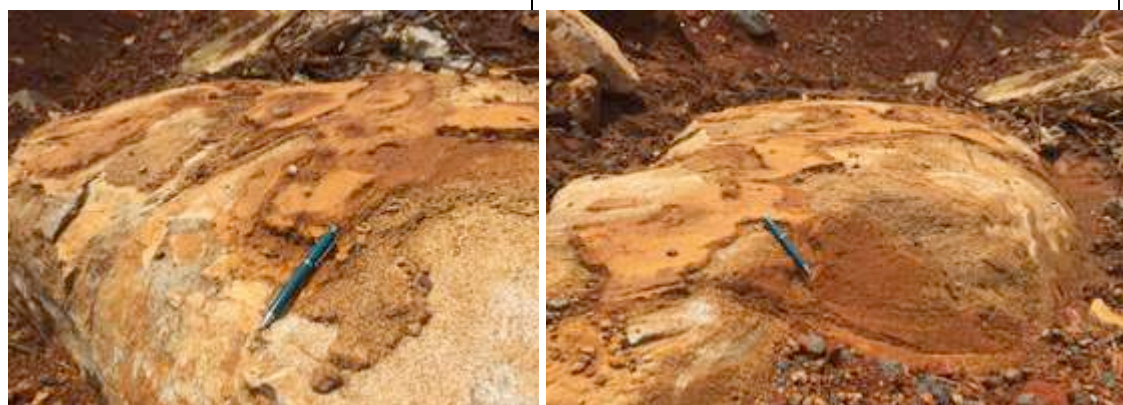
Figure 7-12. Exfoliation / onion-skin weathering on the host rock (Gabbro), photographed in Regent (left) and Malama (right).

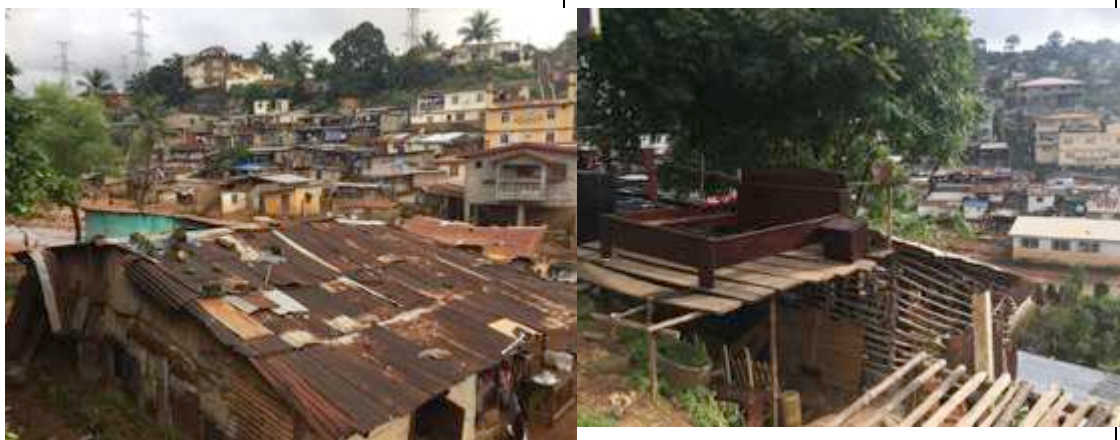
Figure 7-21. The growing colony of informal settlements in Freetown and one of the examples of their attached established livelihood.

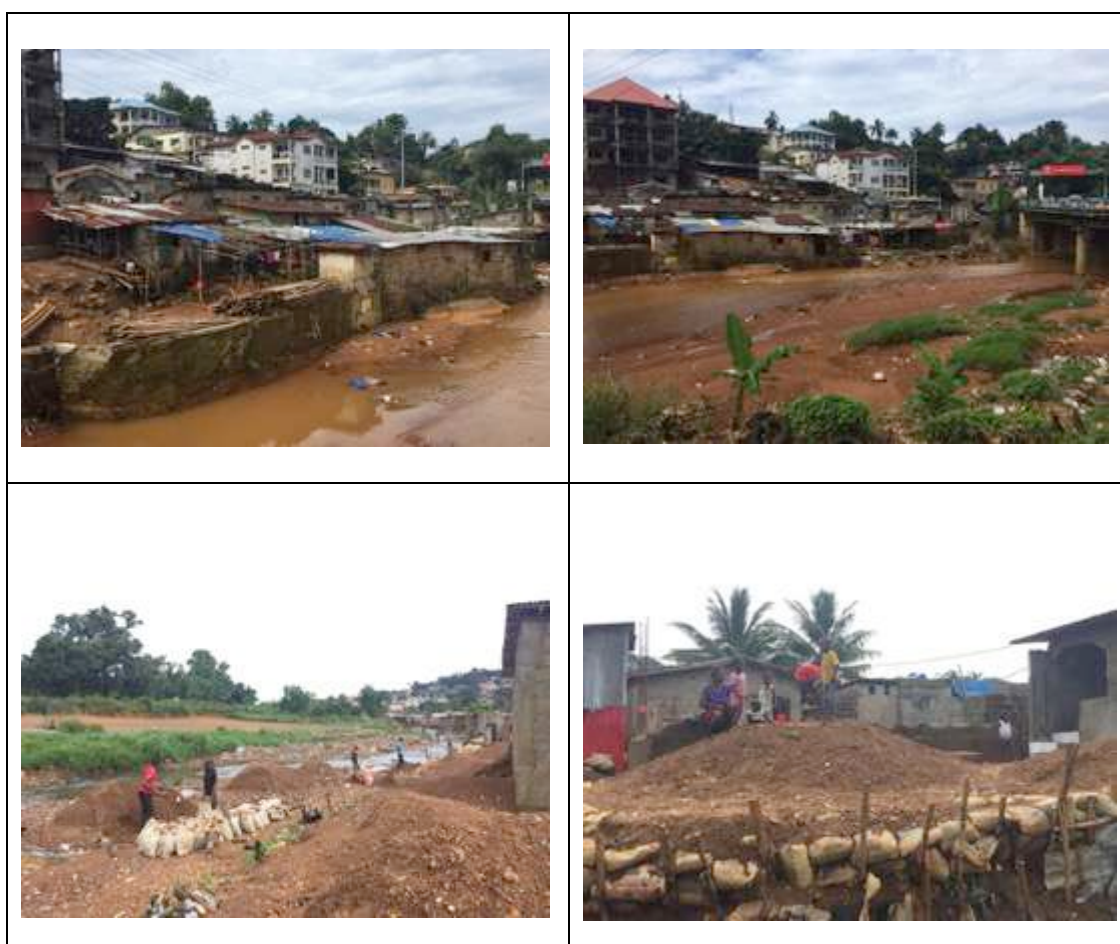
New settlers residing along the river also revealed that the accessibility to water is one of the reasons why they decided to reside there at the first place, in addition to its proximate location in the city center. In fact, the impacts of the recent flood do not change their perception towards risk. The community members organized themselves in cleaning up the sediments brought by the flashflood and use the materials for construction and embankment to their settlements along the river. Positively, this shows community's coping strategy to the impending risk (Figure 7-22).

Figure 7-22. The growing construction of houses on the river bank as the result of low risk perception (top) and the use of river sediments for embankments and construction (bottom).
